Water Compliance Inspection Report

***NPDES
Inspection Report***

***Rod Vande Hoef Dairy
Everson, WA 98247***

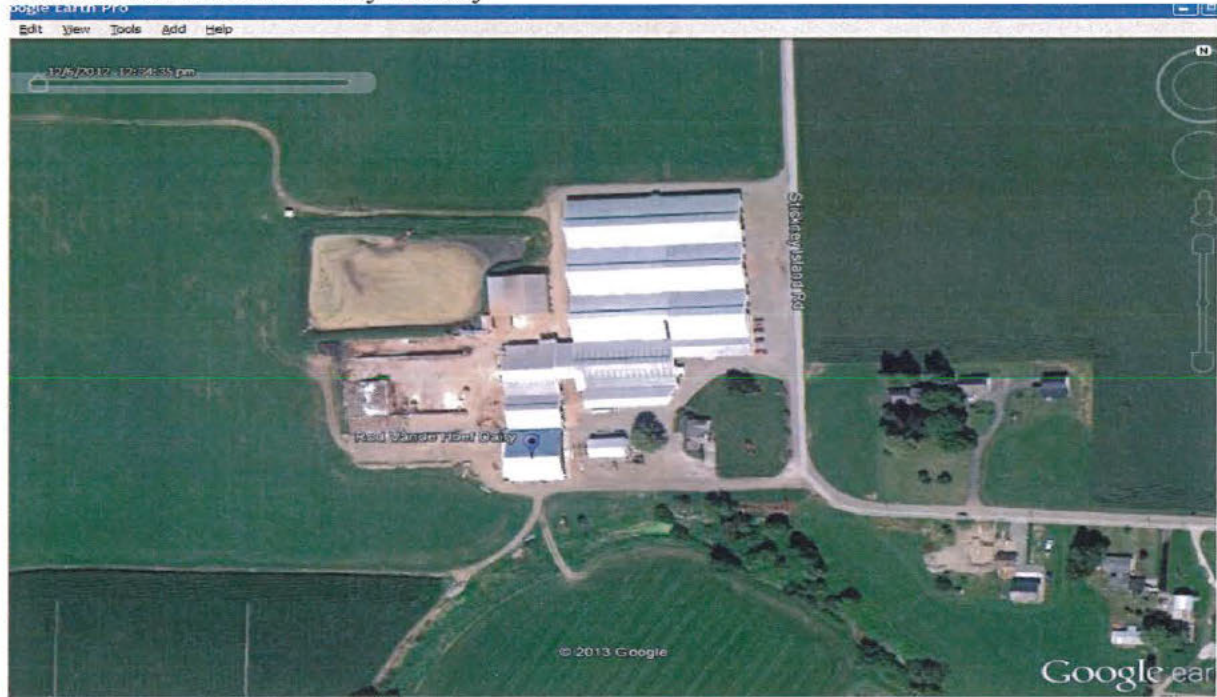
Aerial Photo #1: Main Dairy Facility

Rod Vande Hoef Dairy has confined animals in 3 separate locations. The main facility consists of a barn complex where animals are confined, fed, and maintained. It also includes a milk parlor, a silage storage area, two below ground waste storage tanks, a 1.5 million gallon waste storage lagoon and adjacent pastures. The main facility also has a solid separator and a bedding reclaiming unit. See Attachment A, Aerial Photo #1.

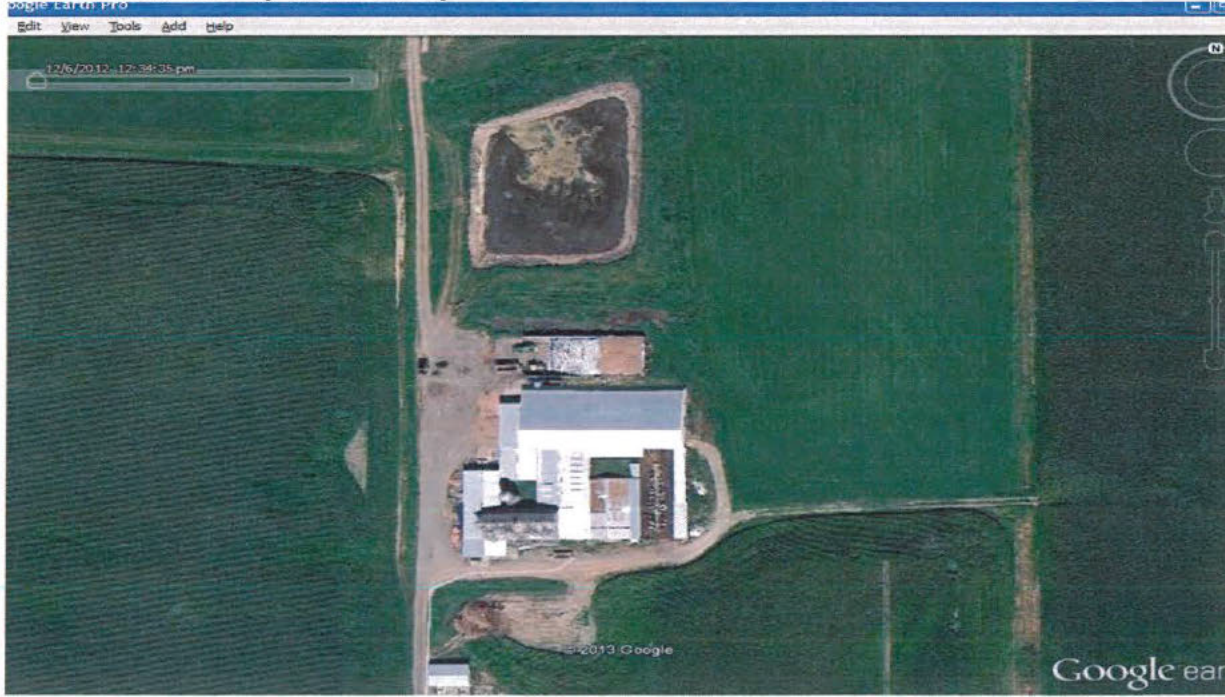
Aerial Photo #2: Dry Cow Facility

The second location is located a half of a mile to the east of the main facility and is where the dry cows are confined, fed, and maintained. It also contains a silage storage area and a 1.3 million gallon waste storage lagoon and adjacent pastures. See Attachment A, Aerial Photo #2.

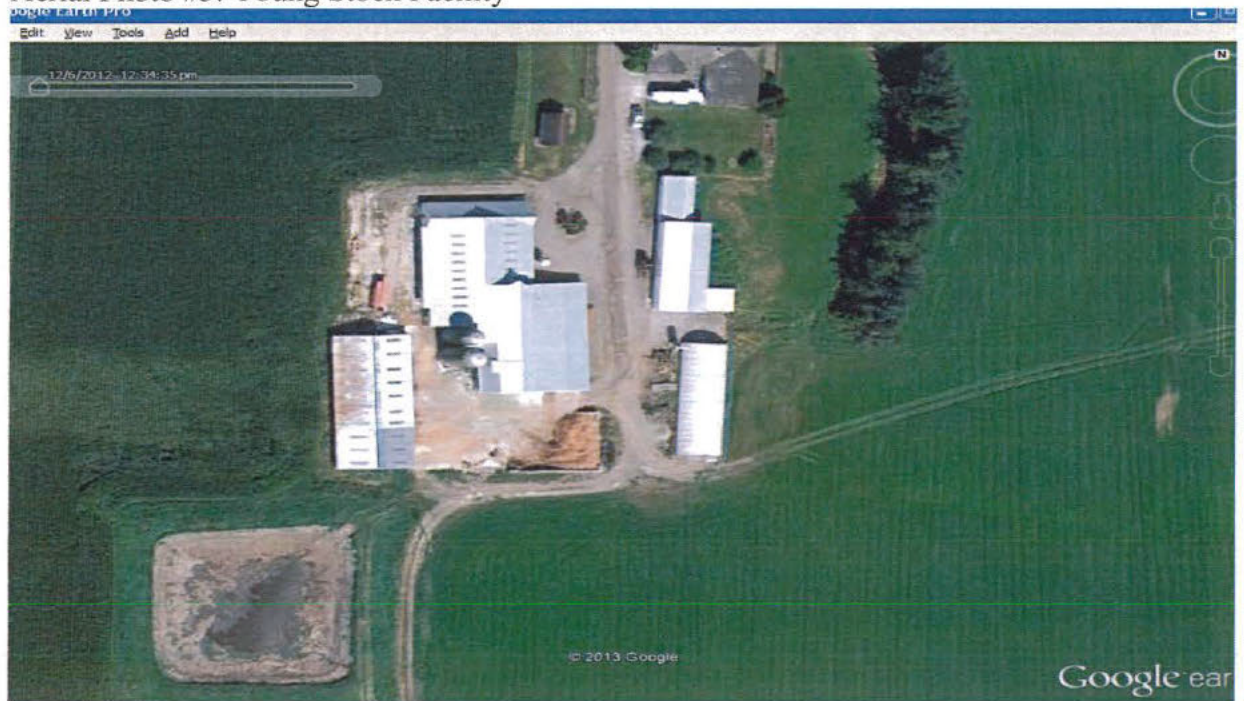
Aerial Photo #3: Young Stock Facility

The third location is a young stock facility which is located a half of a mile northwest of the main facility and consists of a barn complex where animals are confined, fed, and maintained. It also includes a below ground waste storage tank, a solid storage area, a small waste storage lagoon and adjacent pastures. See Attachment A, Aerial Photo #3.

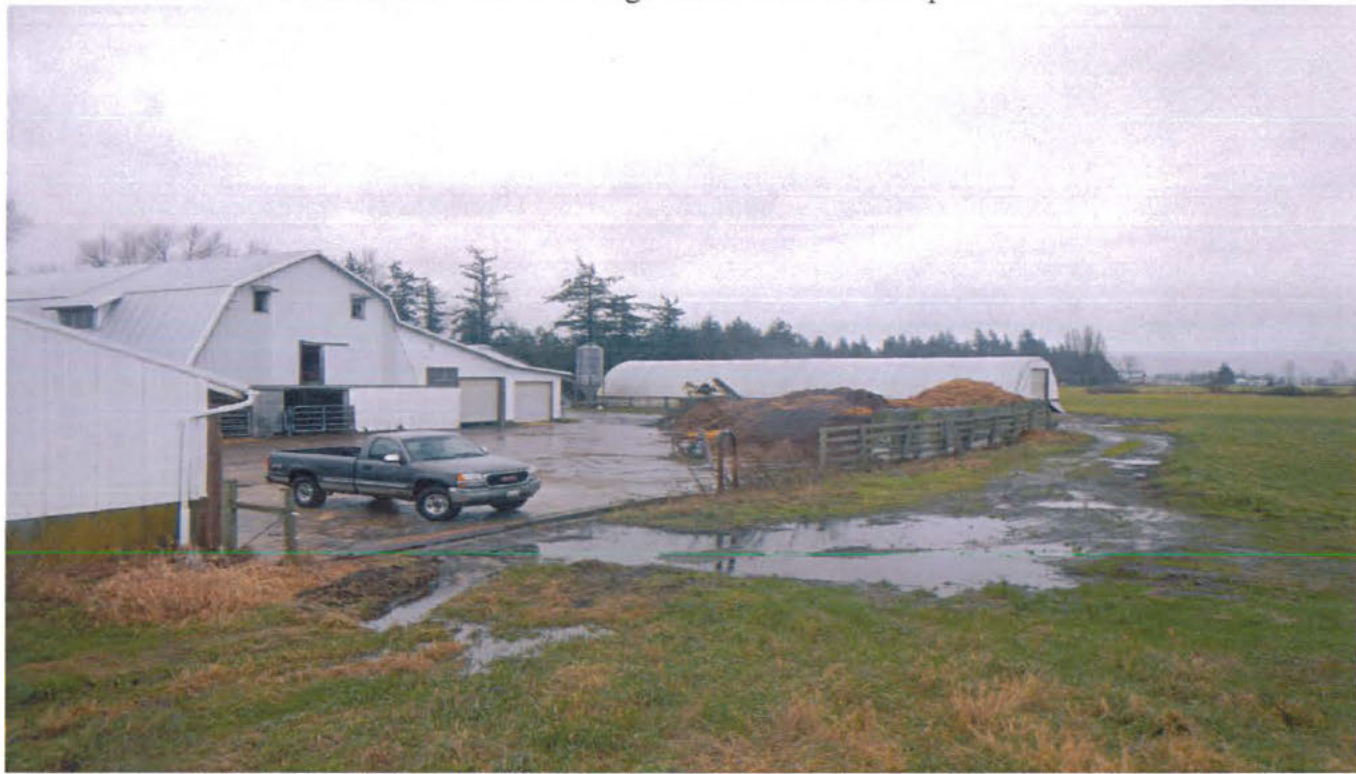
- A. Waste Storage Tank at the Young Stock Facility: At the time of inspection the below ground waste storage tank at the young stock facility was at maximum capacity. See Attachment B, Photo #1, Photo #2. It appeared that some of the liquid from the tank had exited the tank and travelled near a flooded grassy area south of the facility. I informed Mr. Vande Hoef that although surface water wasn't close in proximity to the underground tank, discharges should not be exiting the production area and that the lagoon designed to take the wastewater appears to have the capacity.

Photo #1: Photo facing northeast, showing the surface of the below ground tank located in-between the truck and the uncovered solid storage area on the concrete pad.

Mr. Vande Hoef stated that the underground tank receives stormwater from the paved area and runoff from the uncovered solid storage area. He stated that only solids, not liquid waste is collected and generated from the young stock facility. He said he hadn't checked the tank level for a few days and that he would have tank pumped to the nearby lagoon as soon as possible. Mr. Vande Hoef then called an employee and we observed the tank emptied and transferred to the nearby lagoon prior to our departure.

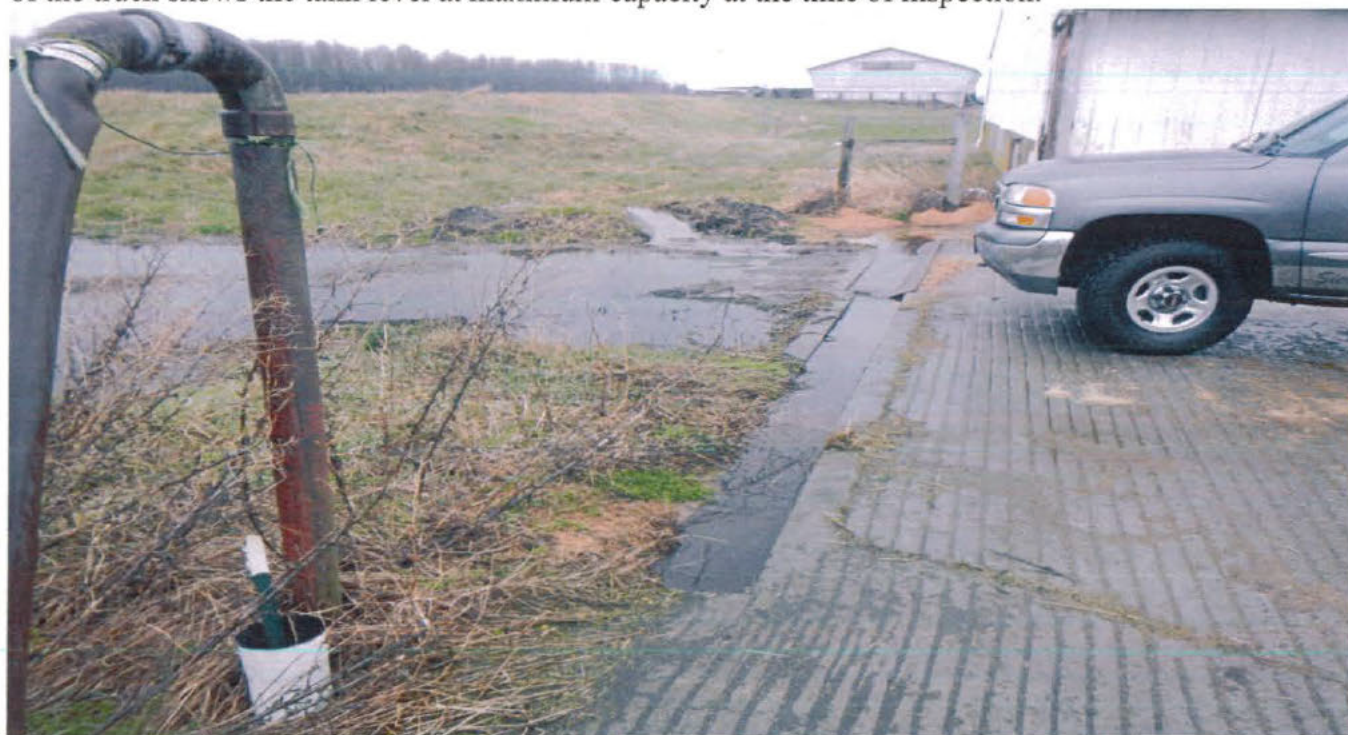
Photo #2: Photo facing west, showing the surface of the below ground tank. The channel in front of the truck shows the tank level at maximum capacity at the time of inspection.
